**Survey and Documentation Services  
12<sup>th</sup> Street Landfill Site  
Wilmington, Delaware**

**(Schnabel Reference 00151122)**

Subject: Contract 00151122, Survey and Documentation  
Services, 12<sup>th</sup> Street Landfill Site, Wilmington,  
Delaware

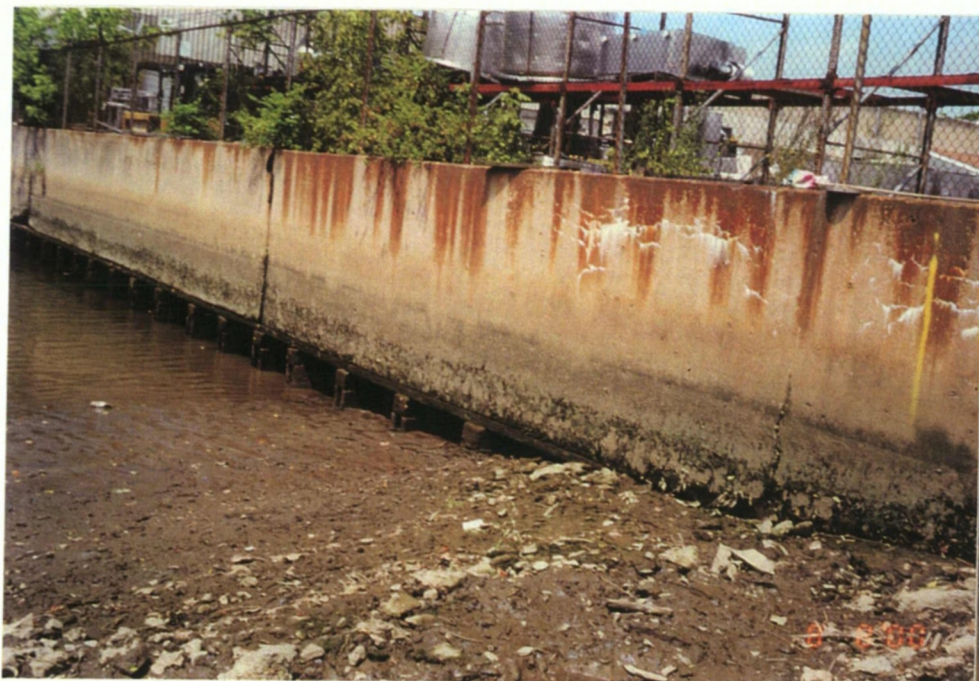
Photo 1

| Photograph | Description |
|---|--|
| 1. | General Overview looking South to North |

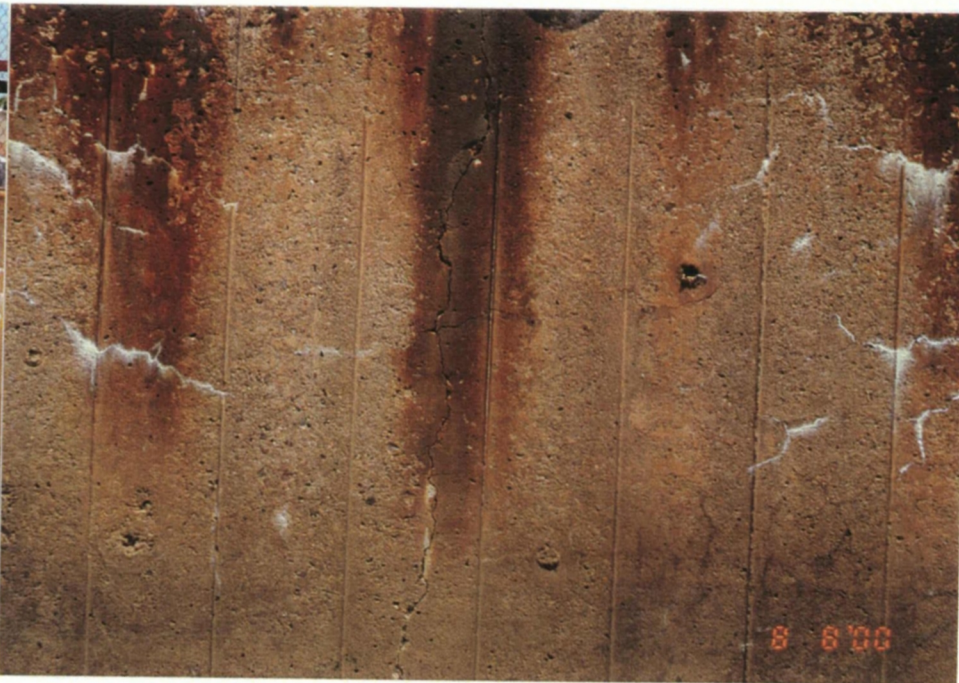
Photo 2

| Photograph | Description |
|---|--|
| 2. | Lower half of 7'6" – 1/16" crack 16' from right end of wall |

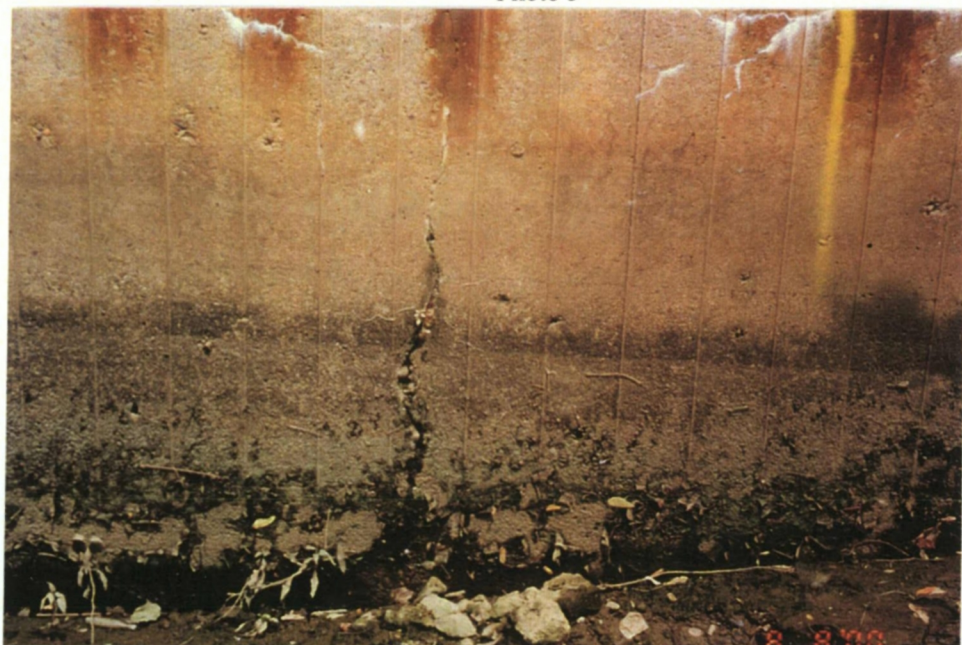
Photo 3

| Photograph | Description |
|---|--|
| 3. | Upper half of 7'6" – 1/16" crack 16' from right end of wall |

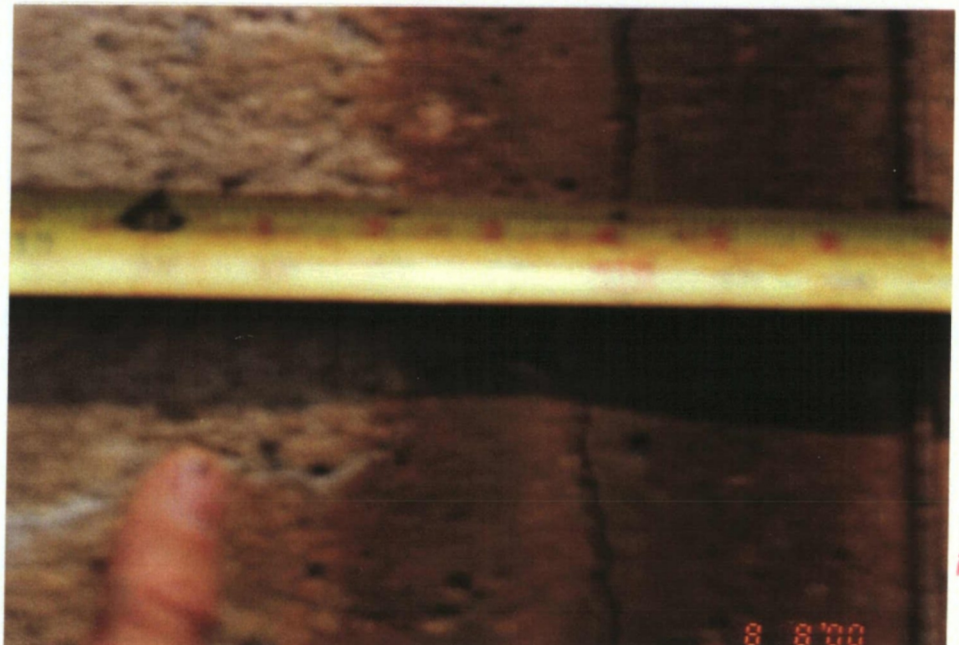
Photo 4

| Photograph | Description |
|---|--|
| 4. | Up close with ruler scale of 7'6" – 1/16" crack |

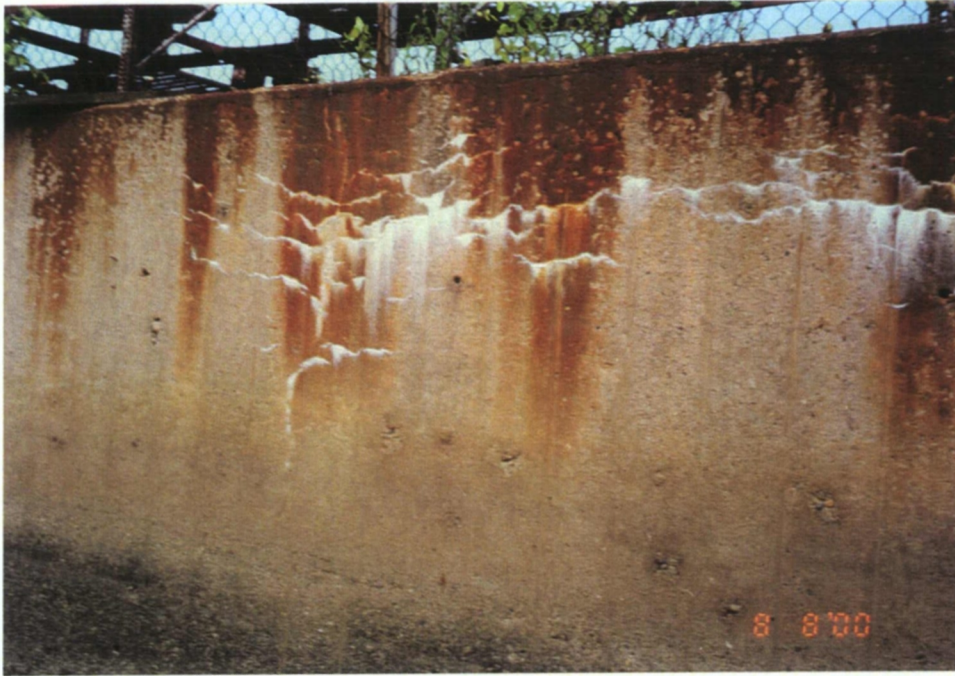
Photo 5

| Photograph | Description |
|---|--|
| 5. | Discoloration – rust / lime corrosion of wall |

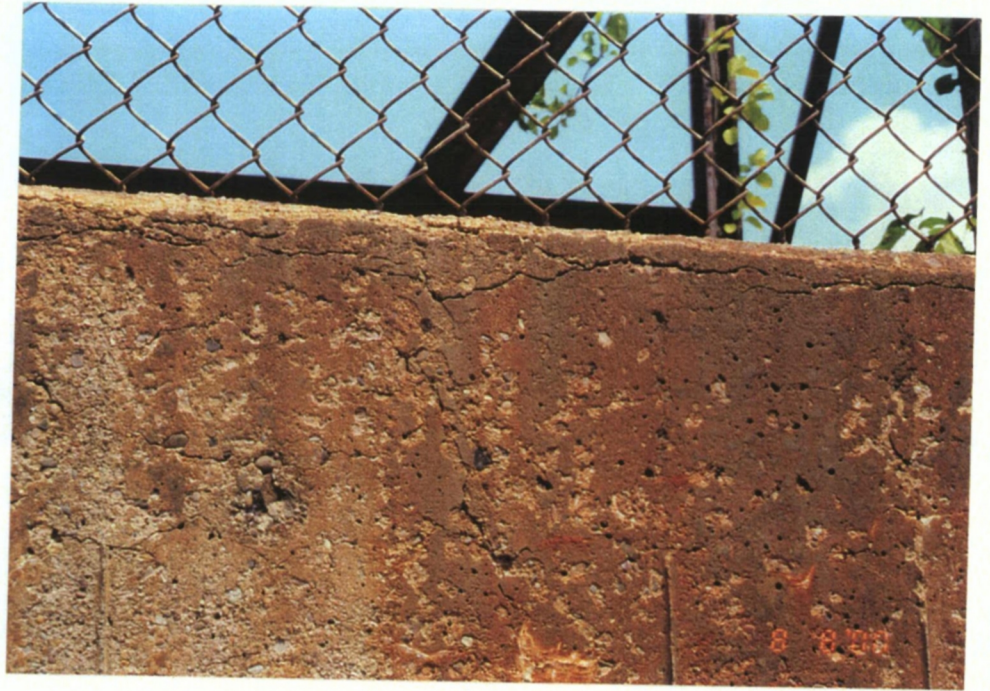
Photo 6

| Photograph | Description |
|---|--|
| 6. | H.L crack at top of wall ~14' long |

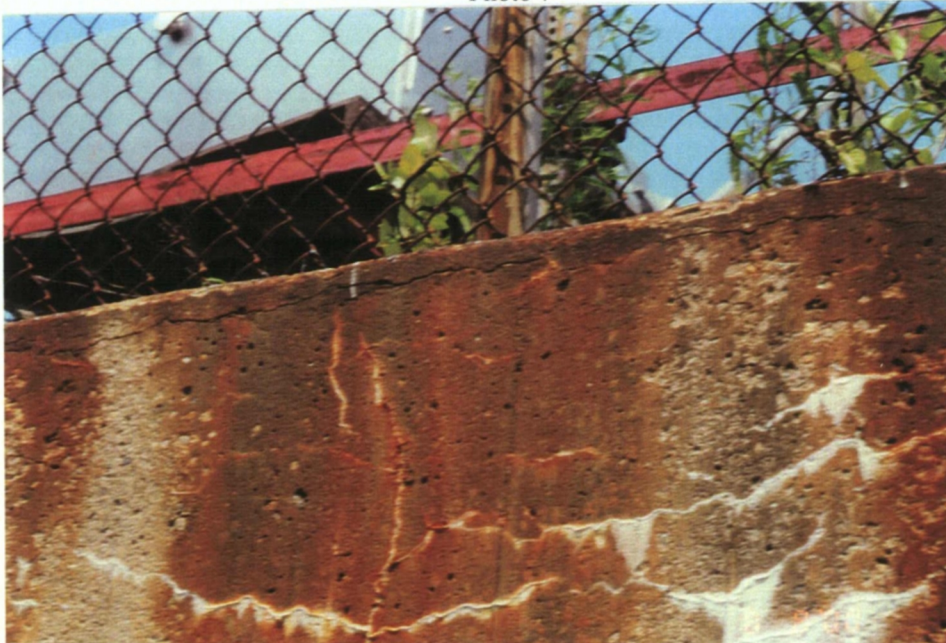
Photo 7

| Photograph | Description |
|---|--|
| 7. | H.L crack at top of wall ~16' long and ~ 30' from end of right end of wall |

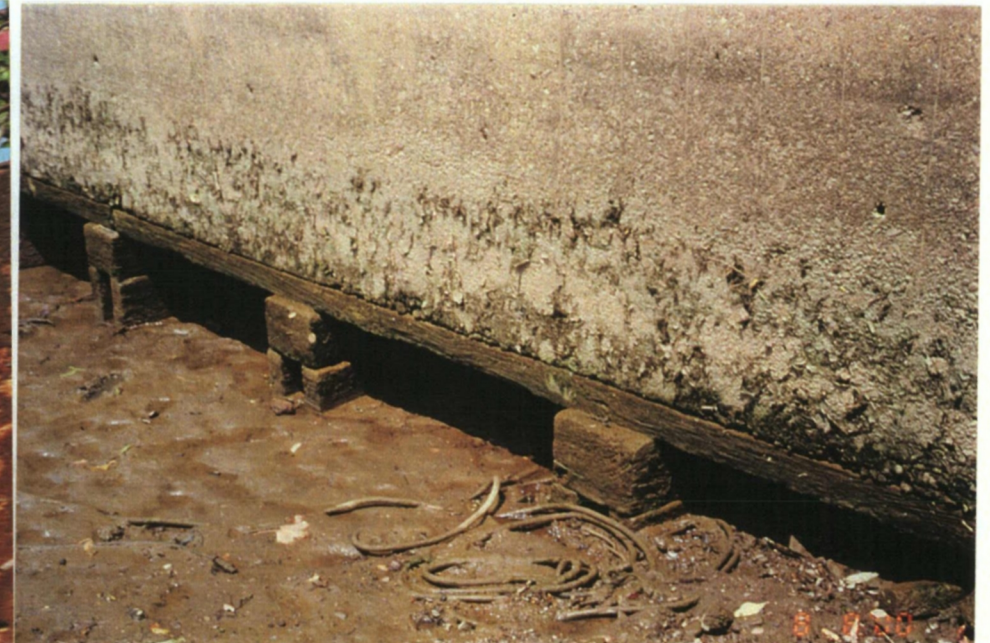
Photo 8

| Photograph | Description |
|---|--|
| 8. | Separation of wall and wooden piling |

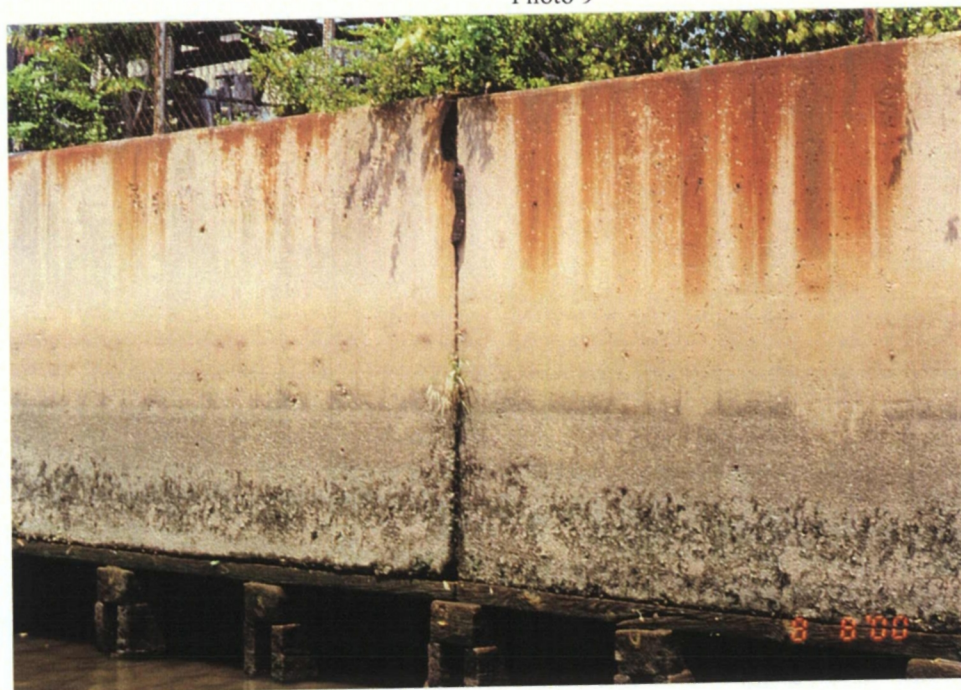
Photo 9

| Photograph | Description |
|---|--|
| 9. | Separation joint 1 |

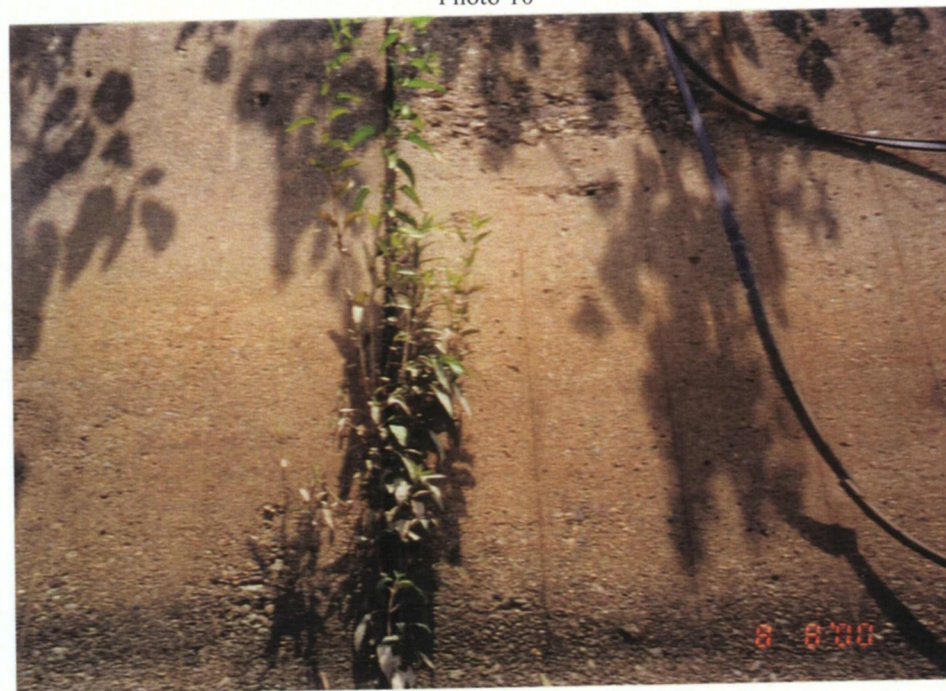
Photo 10

| Photograph | Description |
|---|--|
| 10. | Separation joint 2 |

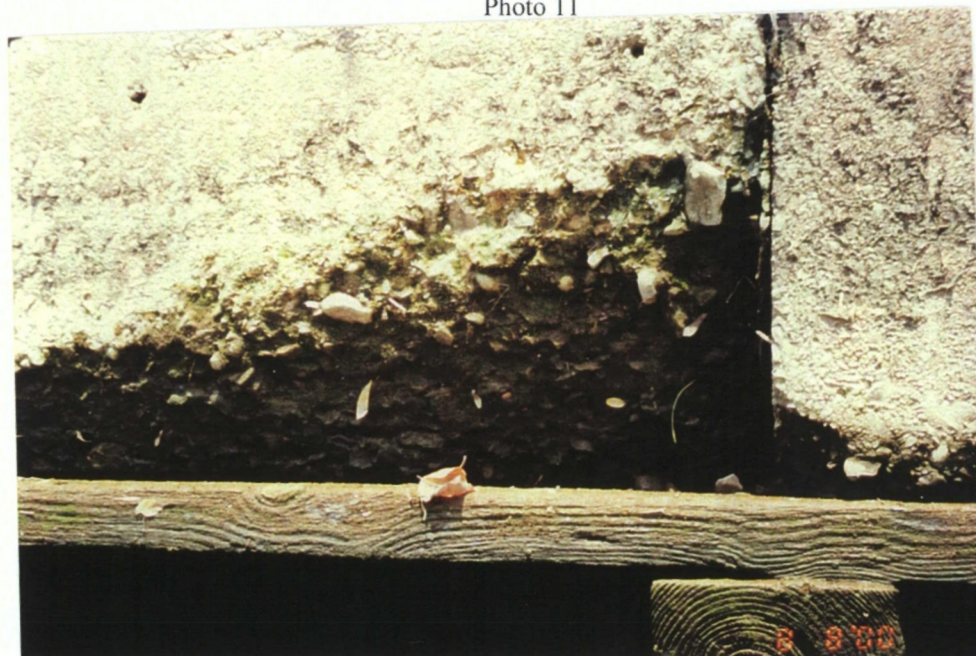
Photo 11

| Photograph | Description |
|---|--|
| 11. | Eroded concrete at bottom of separation joint 2 |

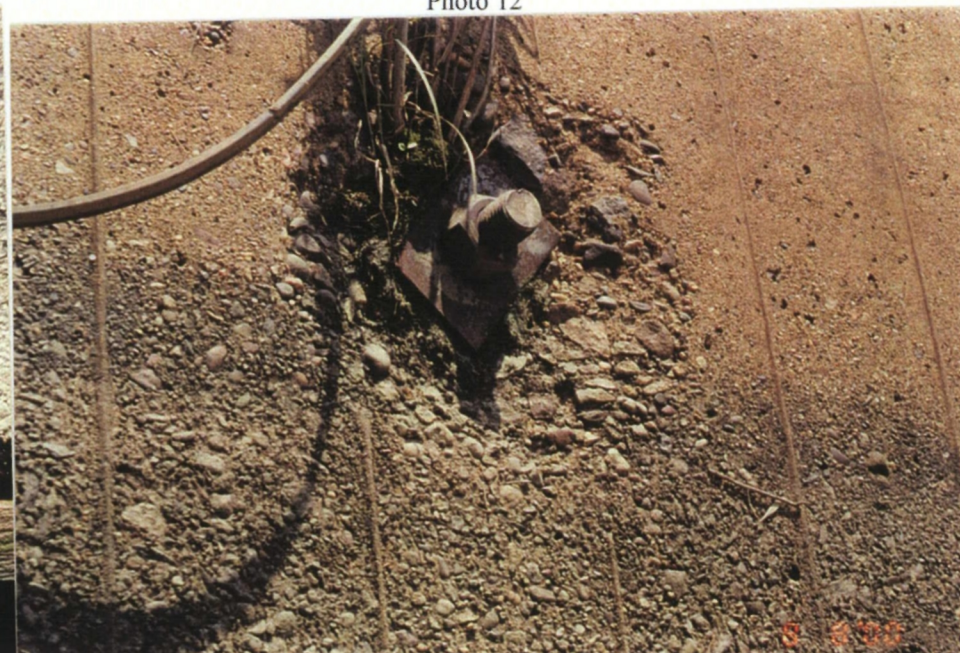
Photo 12

| Photograph | Description |
|---|--|
| 12. | Bolt right of separation joint 2 |

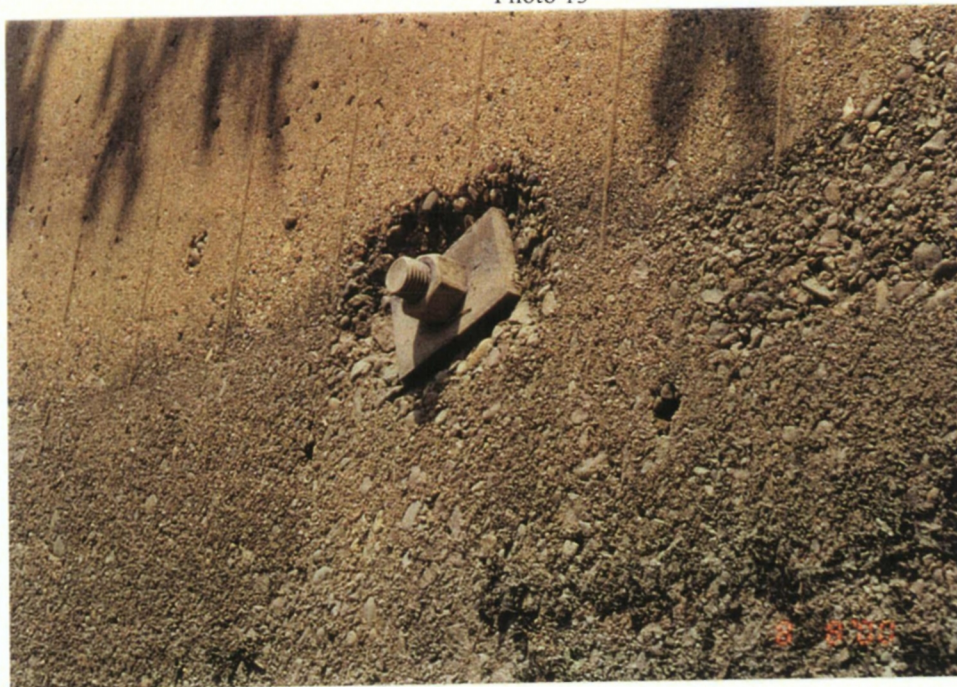
Photo 13

| Photograph | Description |
|---|--|
| 13. | Bolt left of separation joint 2 |

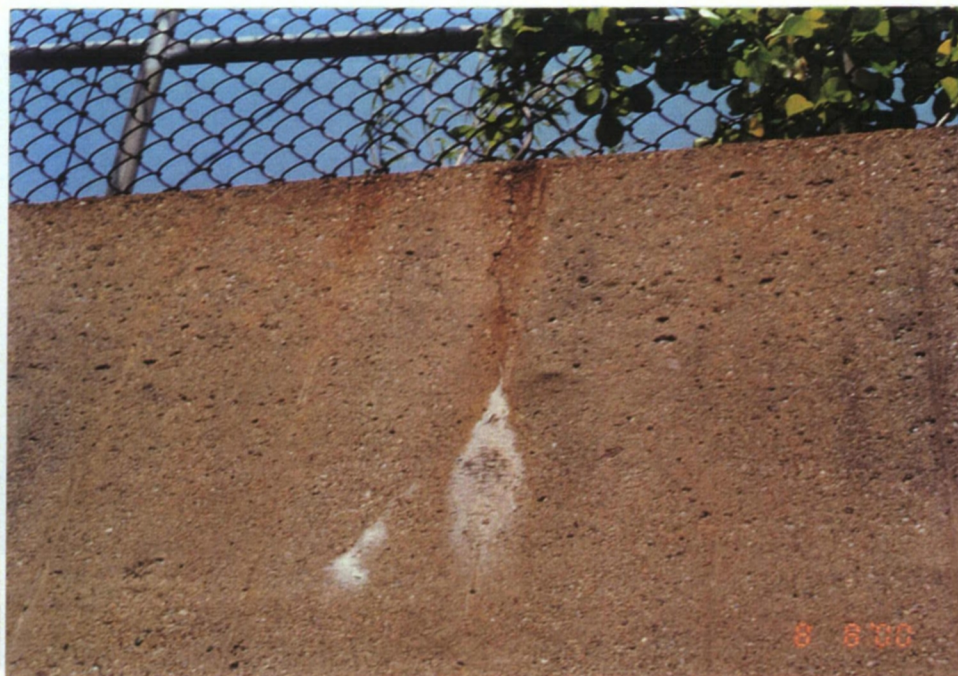
Photo 14

| Photograph | Description |
|---|--|
| 14. | Hair line crack ~ 1' long between separation joints 2 and 3 |

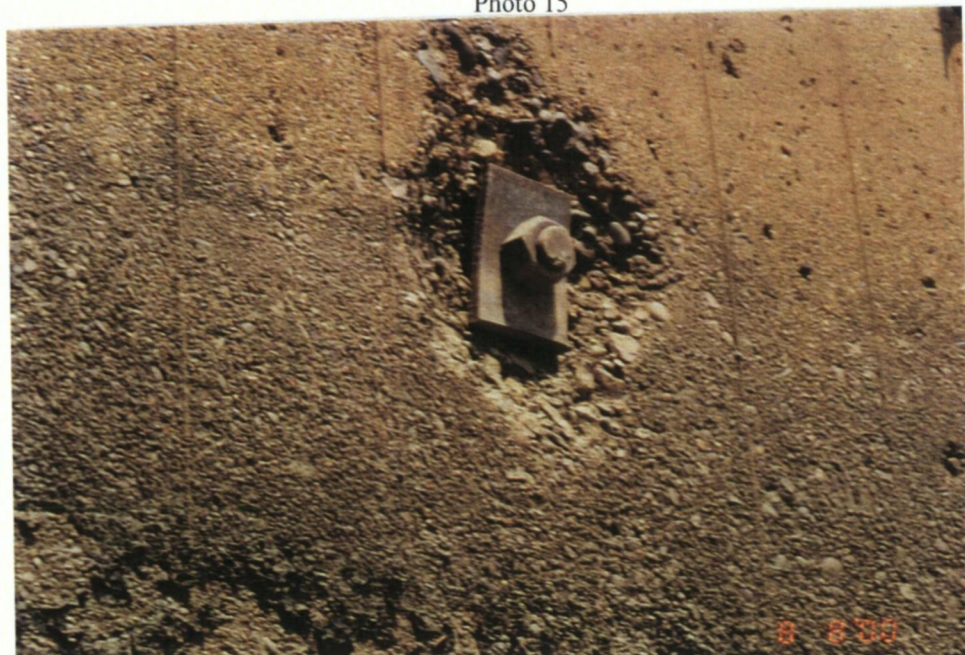
Photo 15

| Photograph | Description |
|---|--|
| 15. | Bolt right of separation joint 3 |

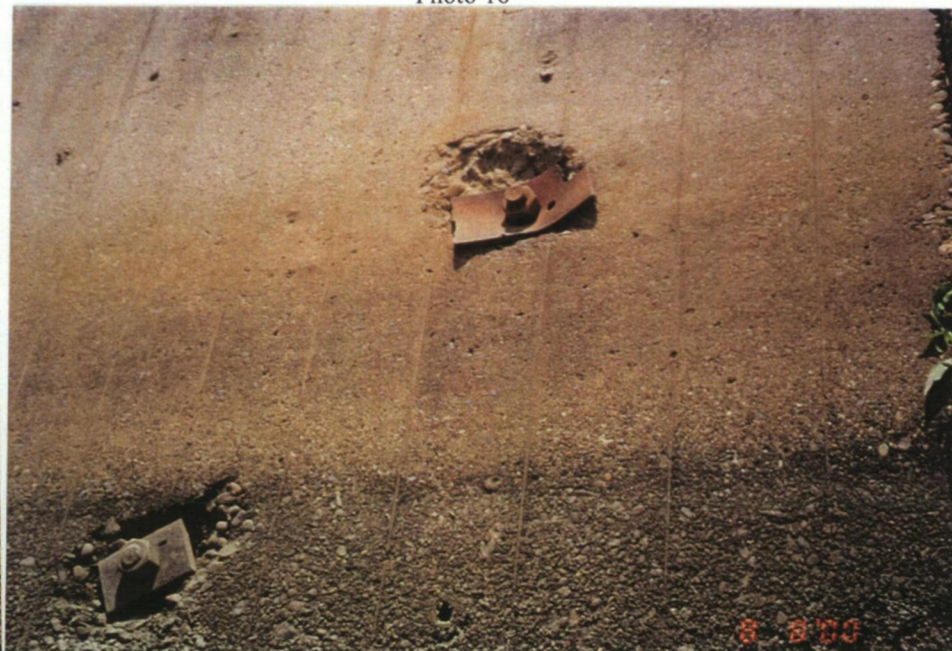
Photo 16

| Photograph | Description |
|---|--|
| 16. | Bolt left of separation joint 3 |

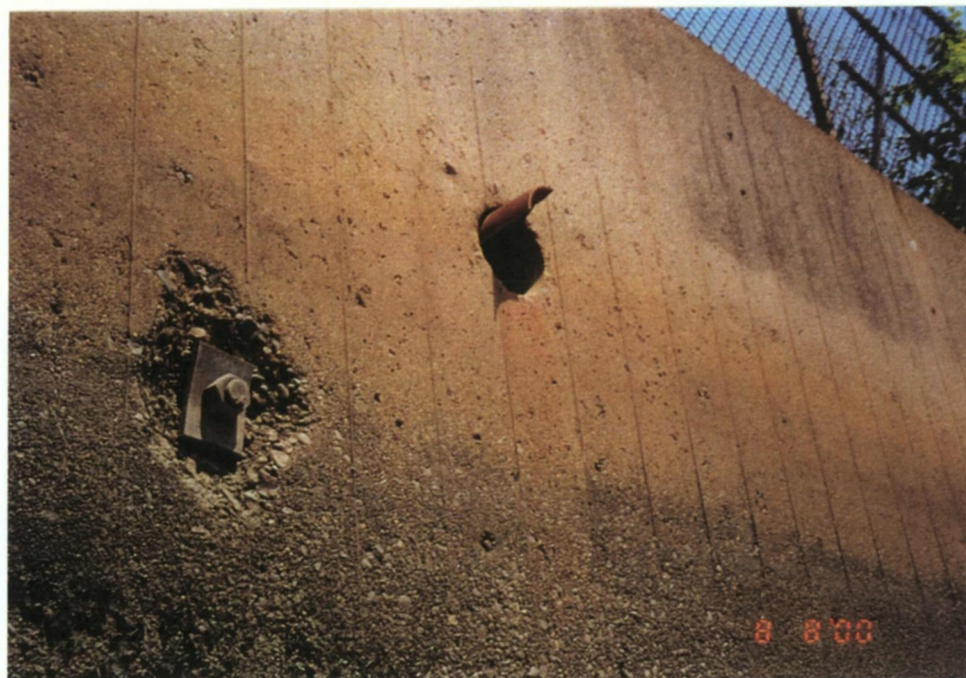
Photo 17

| Photograph | Description |
|---|--|
| 17. | Spout right of separation joint 3 |

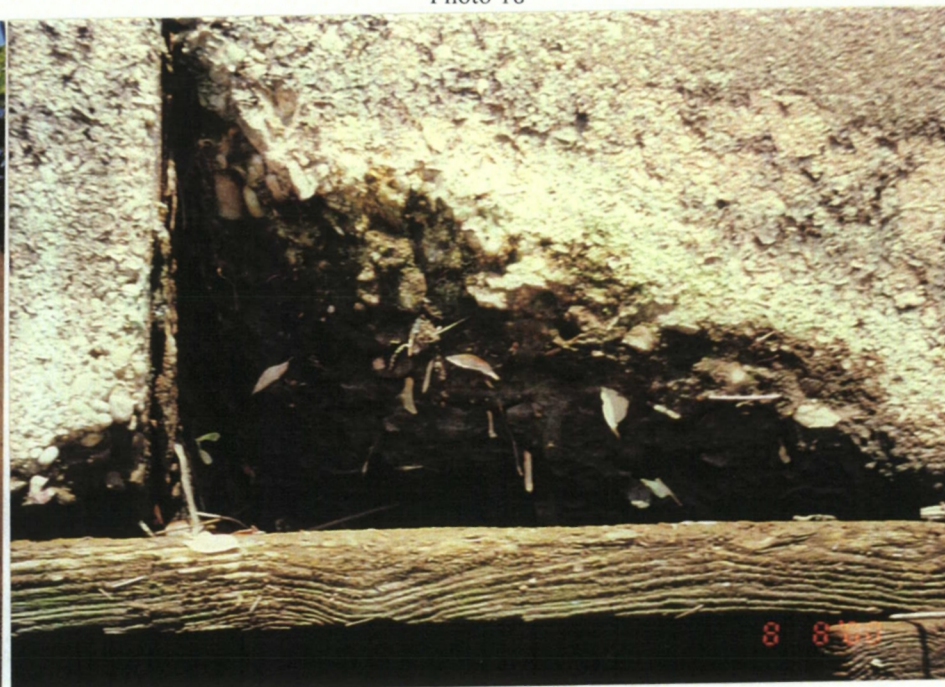
Photo 18

| Photograph | Description |
|---|--|
| 18. | Eroded concrete at bottom of separation joint 3 |

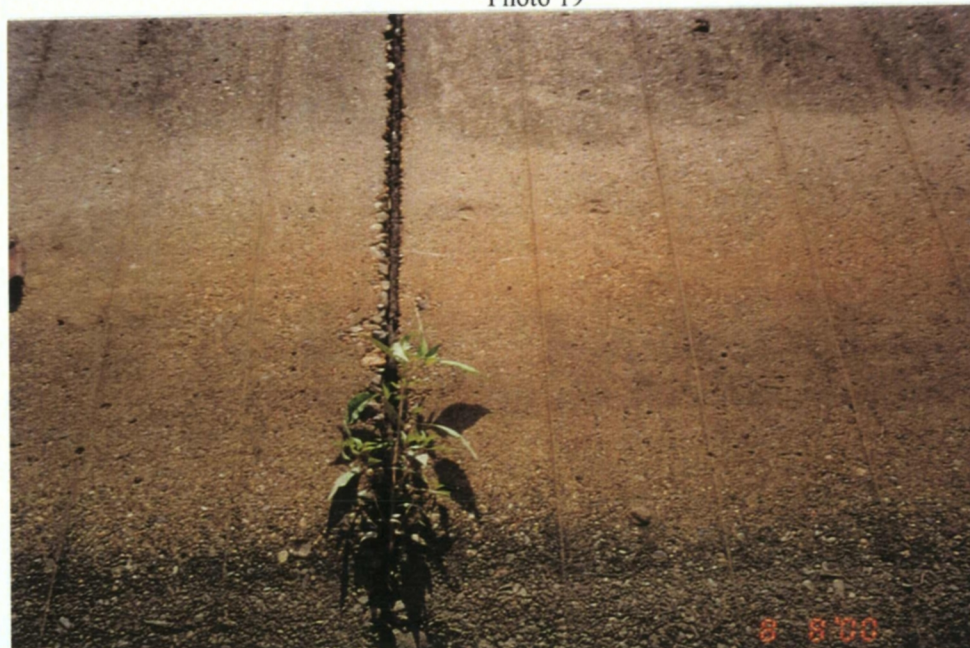
Photo 19

| Photograph | Description |
|---|--|
| 19. | Separation joint 3 |

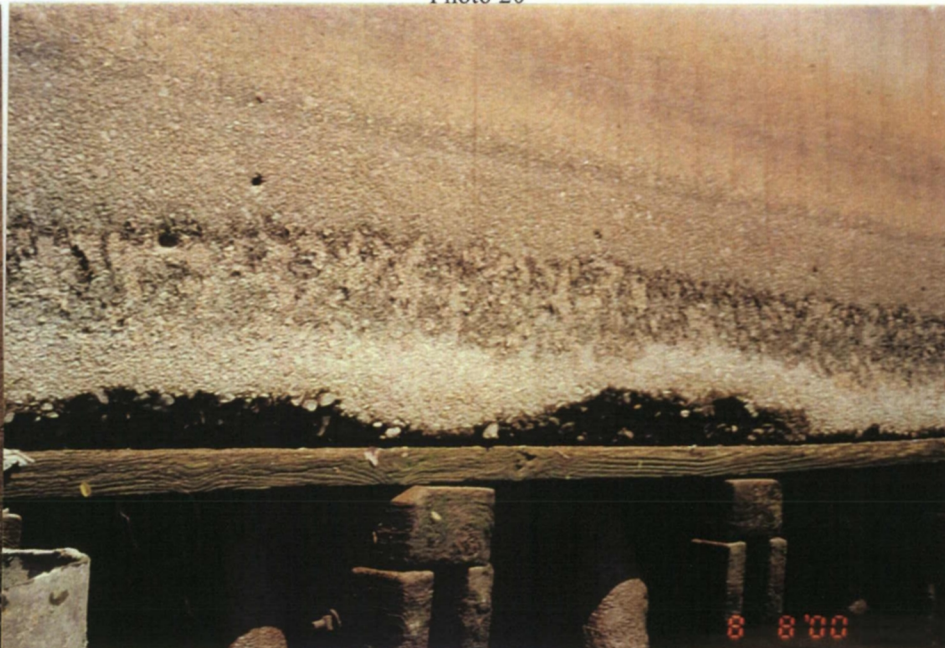
Photo 20

| Photograph | Description |
|---|--|
| 20. | Eroded concrete left of separation joint 3 |

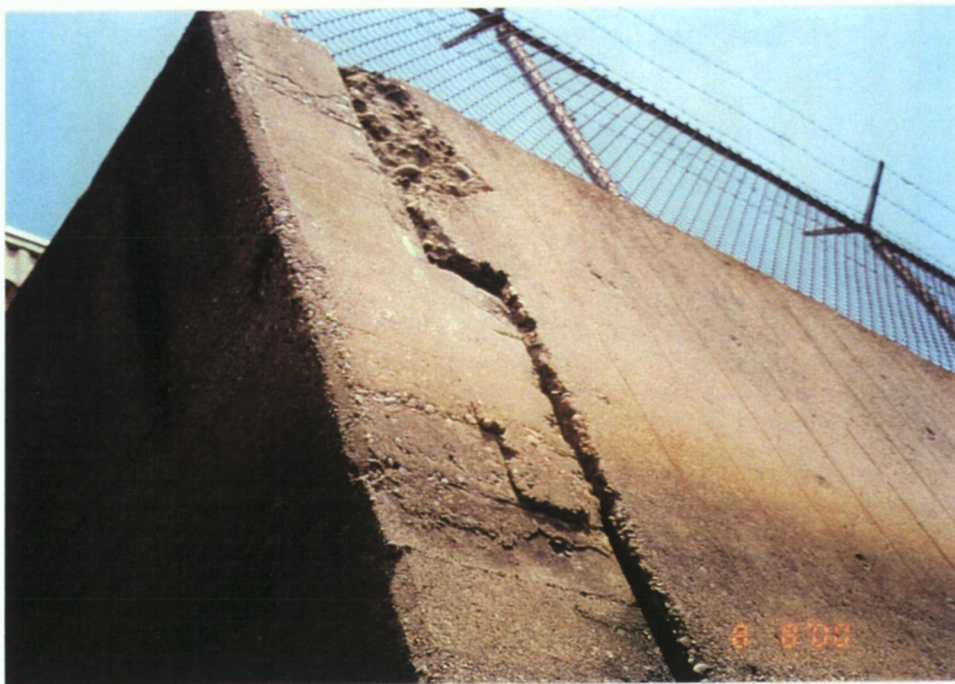
Photo 21

| Photograph | Description |
|---|--|
| 21. | H.L crack at top of the N end slab |

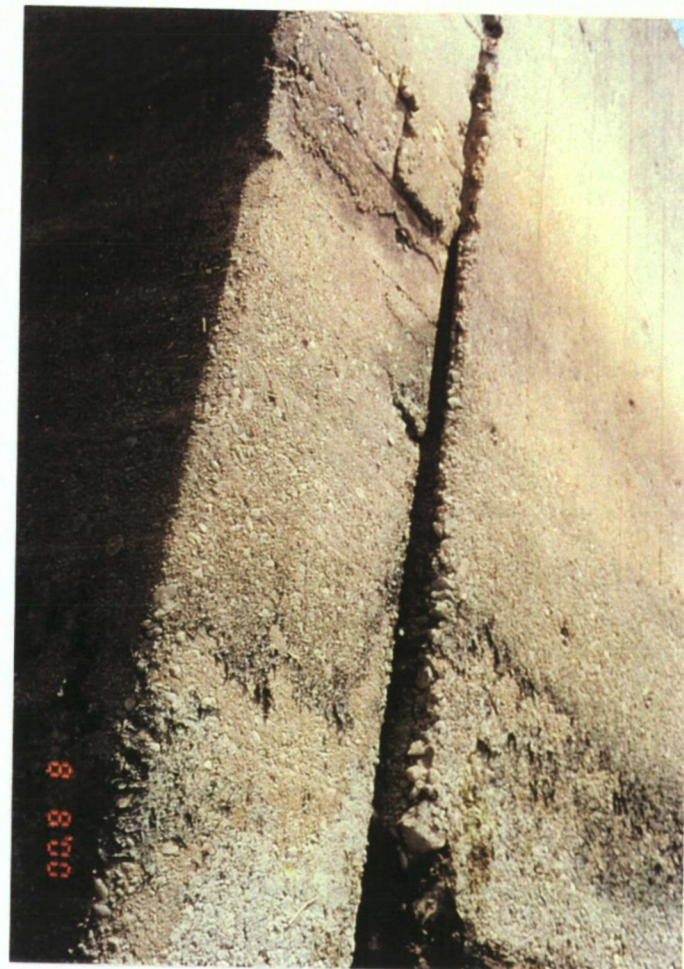
Photo 22

| Photograph | Description |
|---|--|
| 22. | Slab separation at the N end |

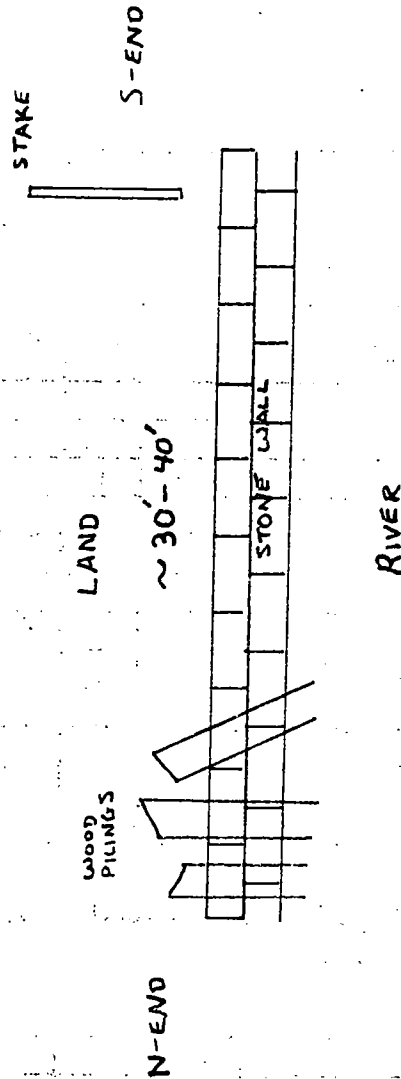
| STRUCTURE | GENERAL BUILDING INFORMATION |
|---|--|
| Stone Wall<br>Structure #2 | Structure #2 is an old stone wall that is severely damaged. The structure is only visible when the river is at low tide. The structure for the most part has already fallen into the river.<br><br>Video Tape Counter Locations:<br>Exterior (Tape 1) – 0:04:44 to 0:06:07<br><br>Drawings – Attachment 3 |

OVERVIEW ON VIDEO - STONE WALL SECTION (VISIBLE AT LOW TIDE)

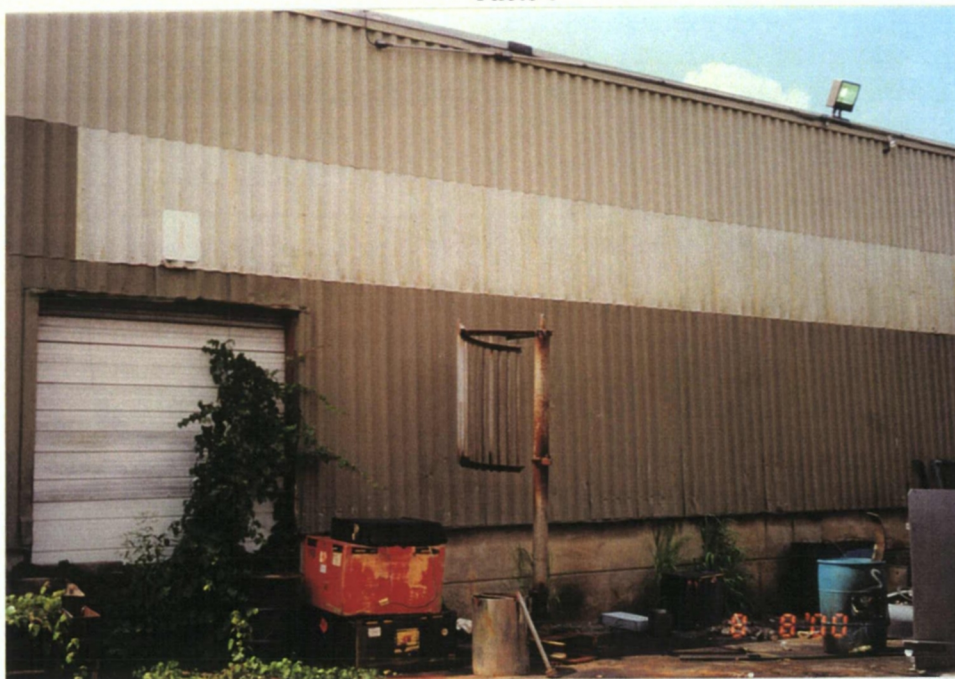
Photo 1

| Roll #1 | Photograph | Description |
|---|---|--|
| | 1. | West side overview |

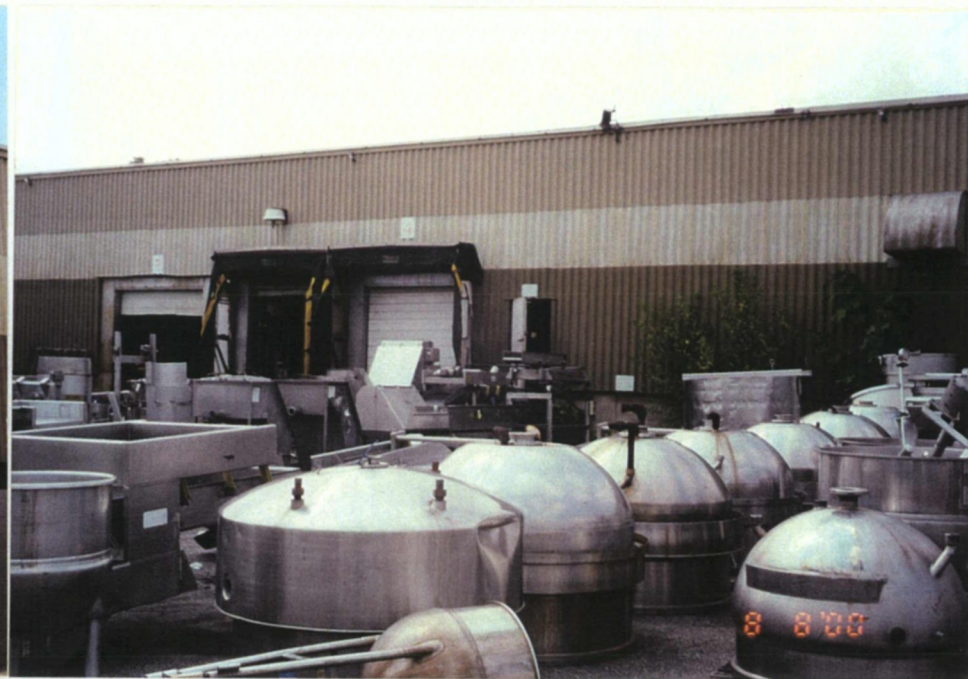
Photo 2

| Roll #1 | Photograph | Description |
|---|---|--|
| | 2. | East side overview |

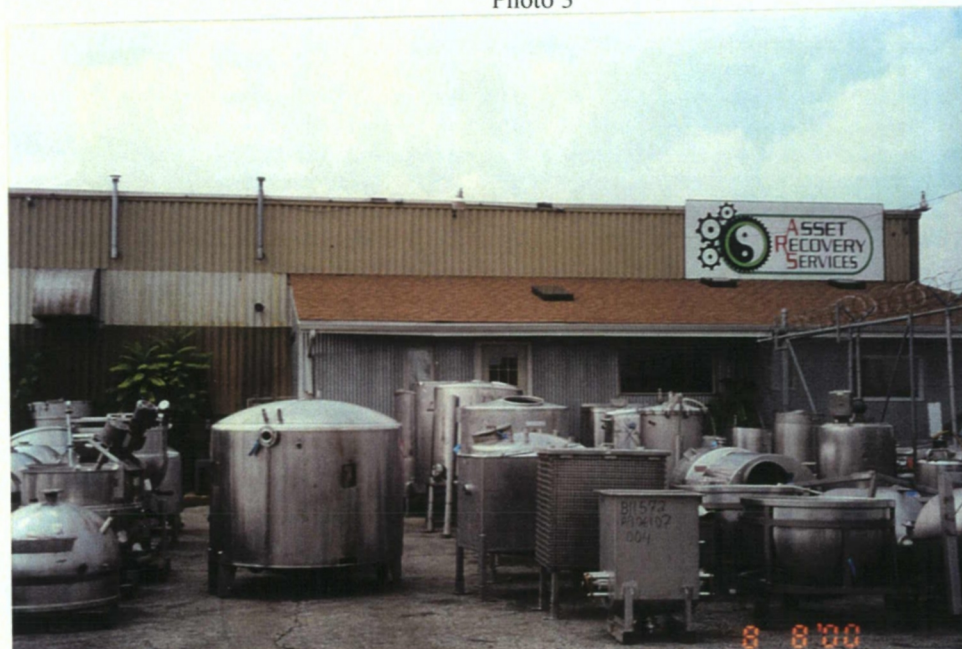
Photo 3

| Roll #1 | Photograph | Description |
|---|---|--|
| | 3. | East side overview (further right) |

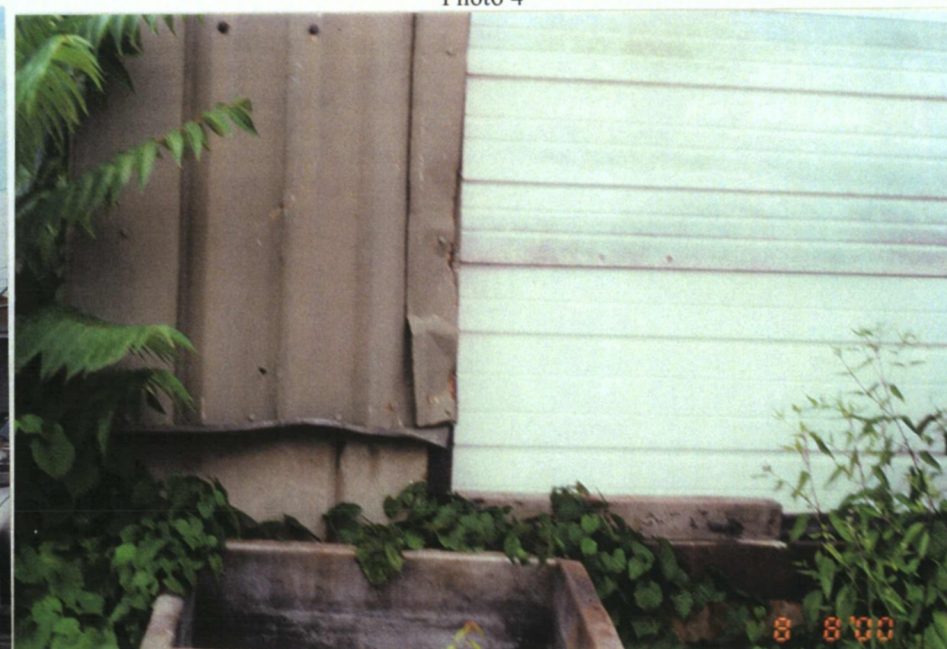
Photo 4

| Roll #1 | Photograph | Description |
|---|---|--|
| | 4. | Damaged siding along garage door #1 |

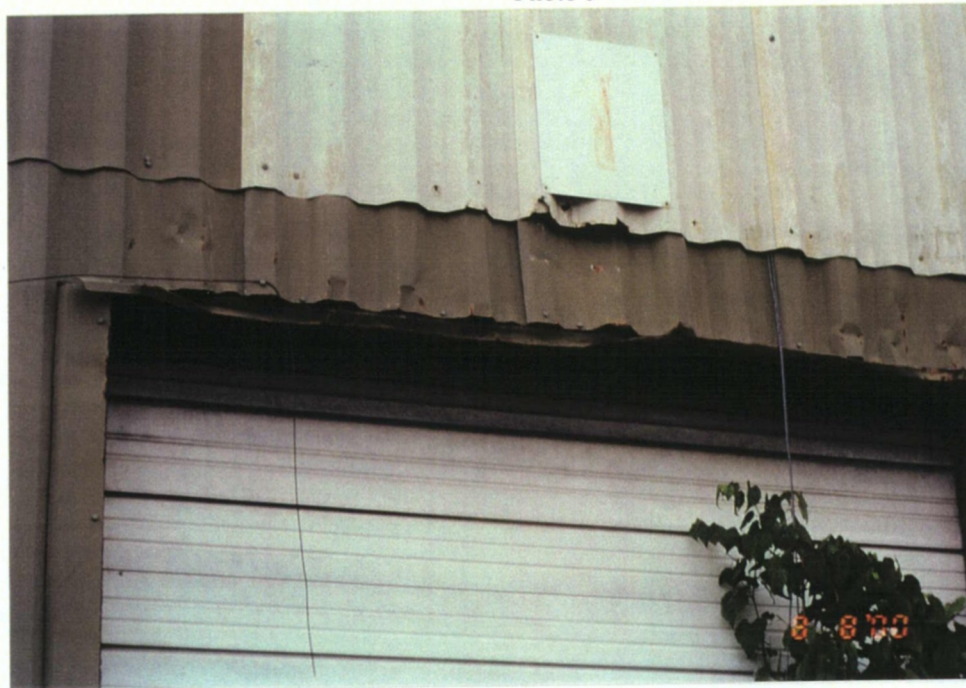
Photo 5

| Roll #1 | Photograph | Description |
|---|---|--|
| | 5. | Damaged siding along garage door #1 |

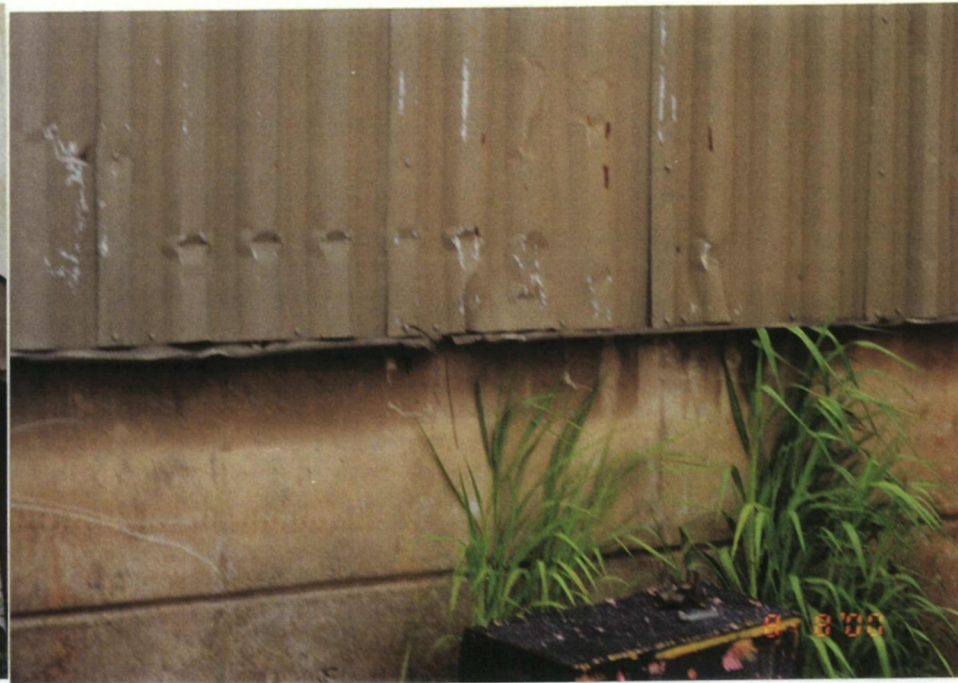
Photo 6

| Roll #1 | Photograph | Description |
|---|---|--|
| | 6. | Damaged siding along Foundation wall ~ 10' right of garage door #1 |

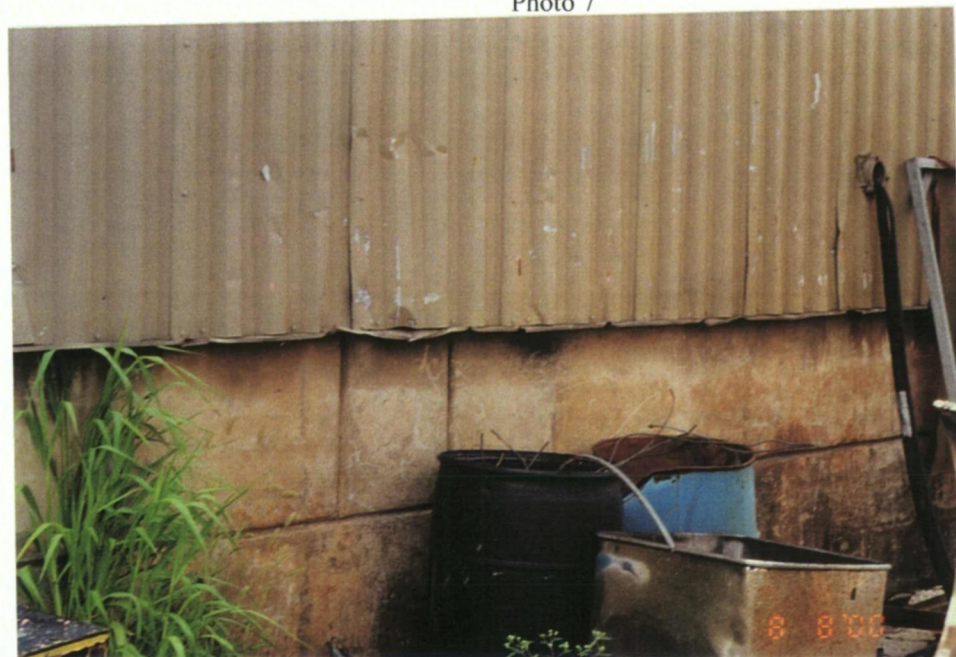
Photo 7

| Roll #1 | Photograph | Description |
|---|---|--|
| | 7. | Damaged siding along Foundation wall ~ 12' right of garage door #1 |

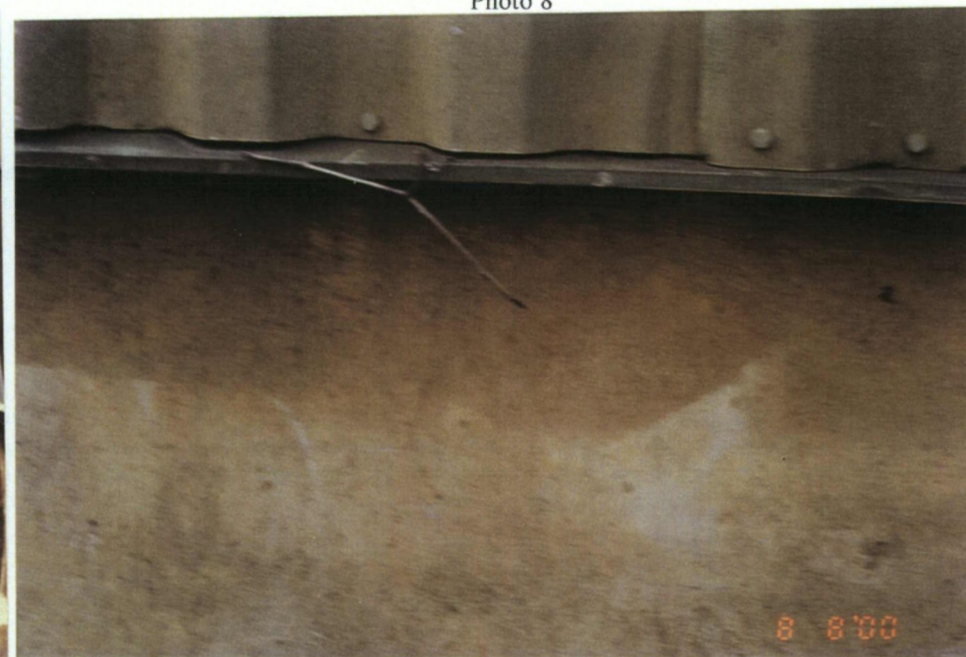
Photo 8

| Roll #1 | Photograph | Description |
|---|---|--|
| | 8. | H.L cracks between garage doors 1 & 2 in foundation wall between 2 and 4 feet long ~6' right of Garage door 1 |

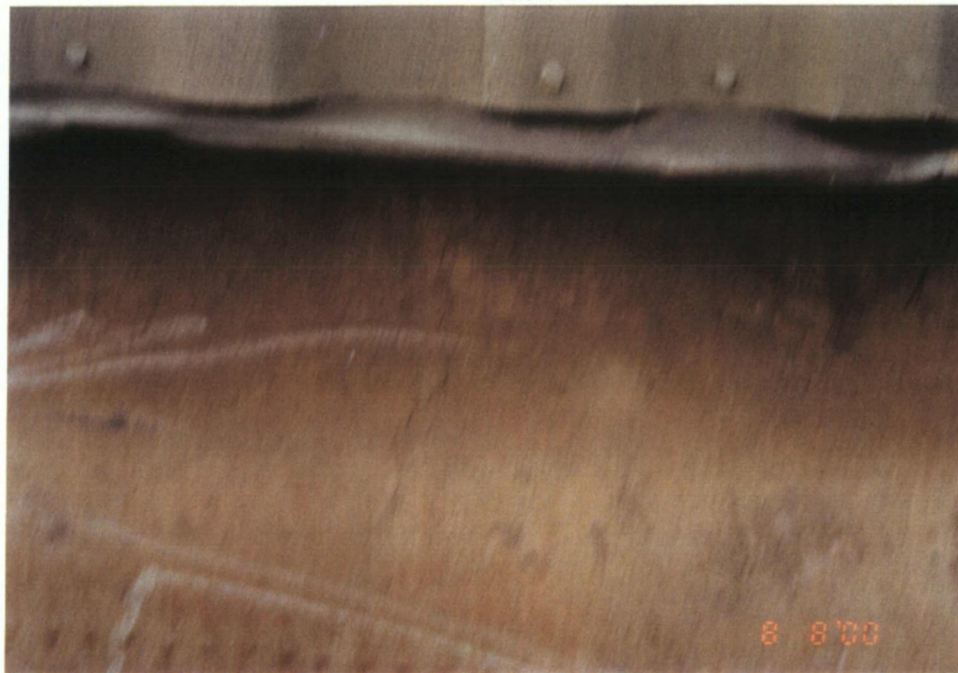
Photo 9

| Roll #1 | Photograph | Description |
|---|---|--|
| | 9. | H.L cracks between garage doors 1 & 2 in foundation wall between 2 and 4 feet long ~ 10' right of Garage door 1 |

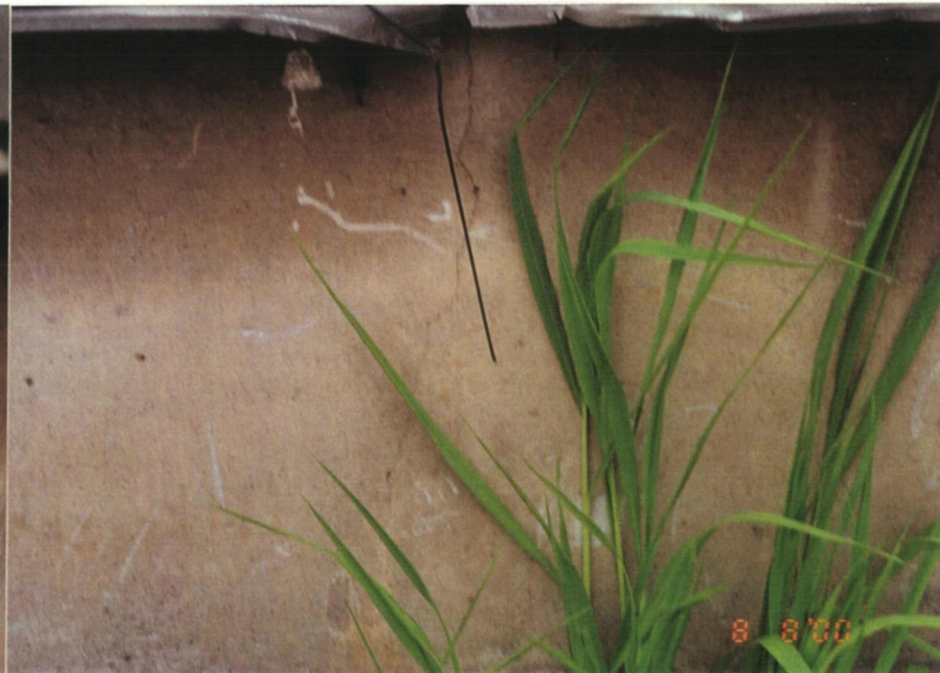
Photo 10

| Roll #1 | Photograph | Description |
|---|---|--|
| | 10. | H.L cracks between garage doors 1 & 2 in foundation wall between 2 and 4 feet long ~13' right of Garage door 1 |

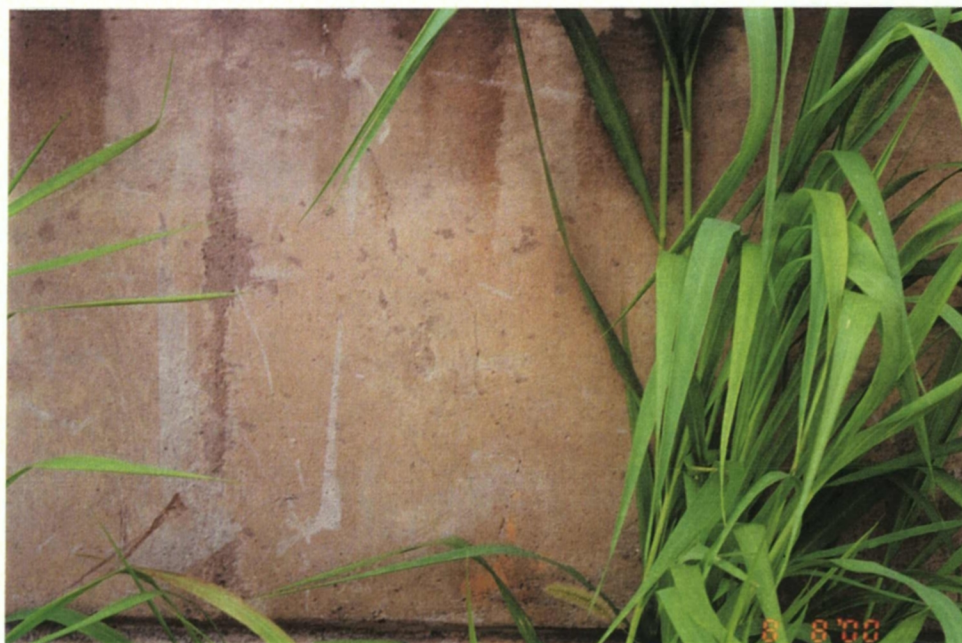
Photo 11

| Roll #1 | Photograph | Description |
|---|---|--|
| | 11. | H.L cracks between garage doors 1 & 2 in foundation wall between 2 and 4 feet long ~ center line between the two doors |
